BRISTOL FISH AND GAME CLUB DAM
CT-00299

PHASE I INSPECTION REPORT
NATIONAL PROGRAM OF INSPECTION OF DAMS

Name of Dam: BRISTOL FISH AND GAME CLUB DAM
Inventory Number: CT 00299
State: CONNECTICUT
County: NEW HAVEN
Town: WOLCOTT
Stream: CUSSGUTTER
Owner: BRISTOL FISH AND GAME CLUB
Date of Inspection: APRIL 29, 1981
Inspection Team: PETER M. HEYEN, P.E.
MURALI ATLURU, P.E.
JAY A. COSTELLO

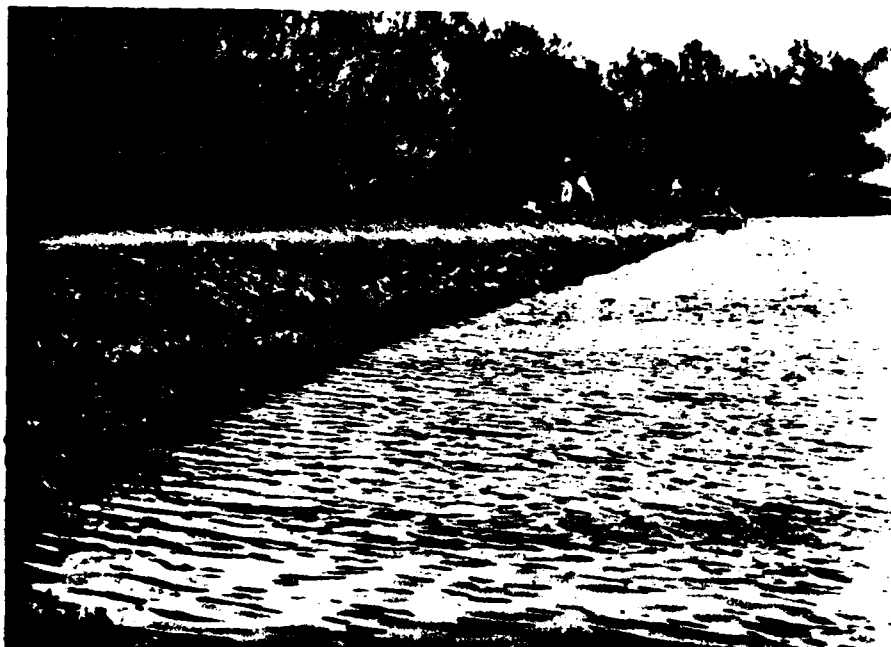
Photo 1 - Upstream slope from left abutment. Minor sloughing of the upstream slope is occurring at the waterline. Drop inlet can be seen at center of dam (April, 1981).

2. Regrading of the upstream slope and placement of sufficient riprap to protect against erosion and sloughing of this slope by wave action. This riprap should be placed between expected high and low water elevations, and should extend around the right end of the embankment to protect against erosion should the emergency spillway be activated.
3. Repairing spalled concrete at the sides of the riser structure hood, along the waterline where water enters the drop inlet.
4. Removing trees to a distance of 10 feet from the toe of the dam with proper backfilling and replacement of protective cover.
5. Elimination of burrowing animals in the embankment, backfilling the burrows and replacement of protective cover.

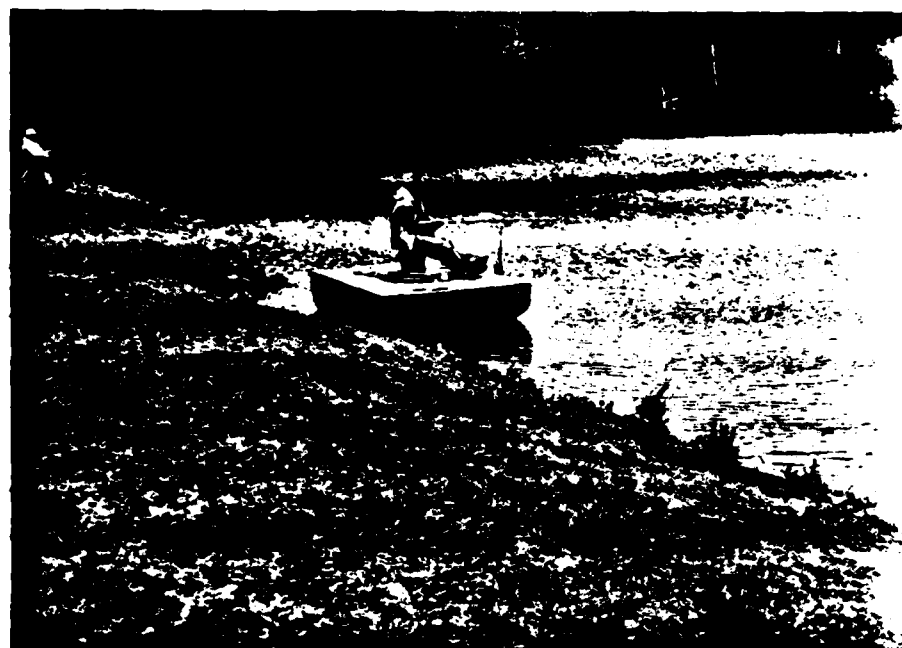
Photo 3 - Top of concrete riser structure. Casing for low-level outlet valve stem is located on upstream side of riser (April, 1981).

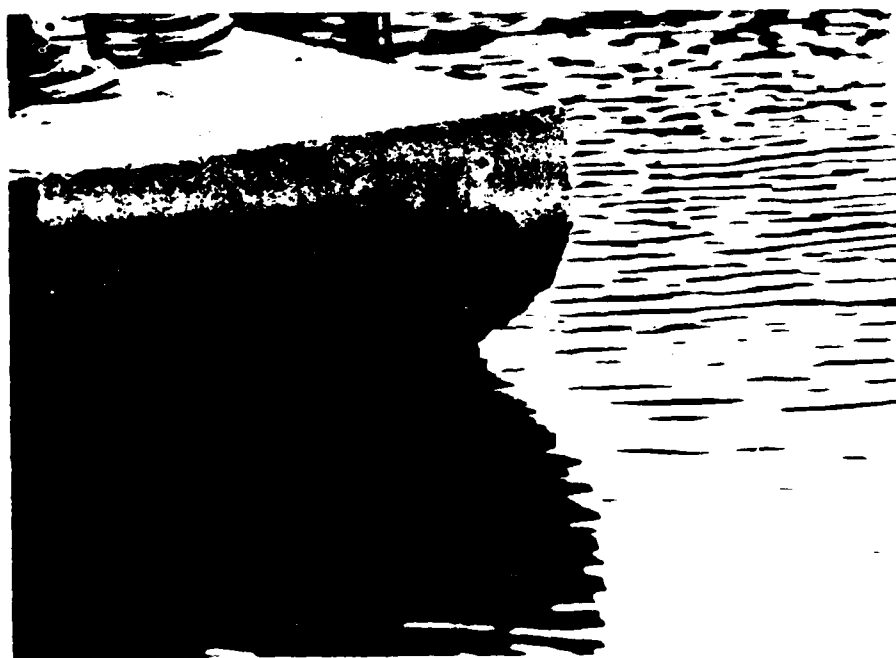
Photo 6 - Close-up of riser structure and spalling of concrete at waterline (April, 1981).

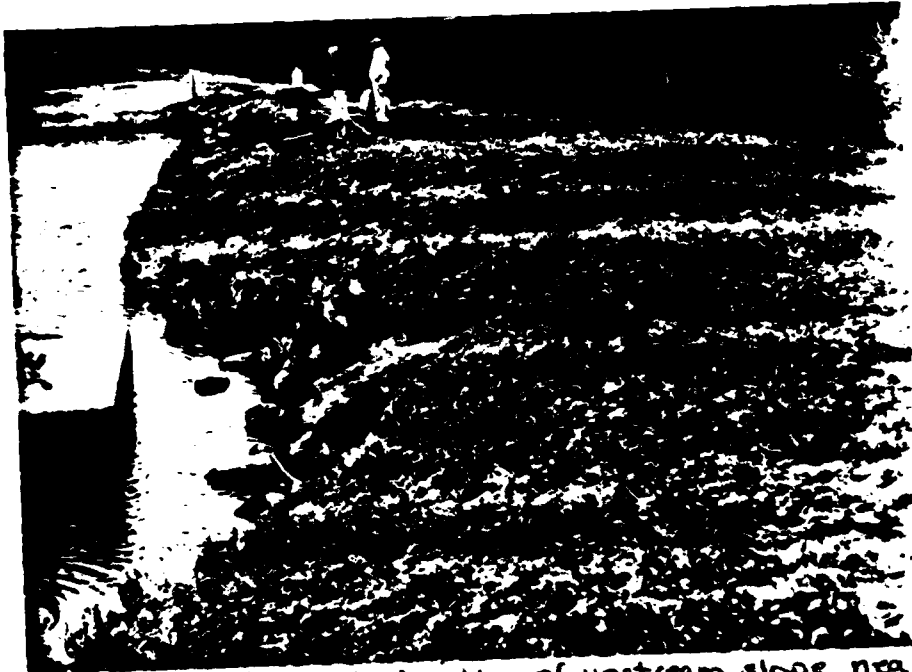
Photo 7 - Erosion and sloughing of upstream slope near drop inlet. Note sparse riprap at waterline (April, 1981).
